# GRAMPAW PETTIBONE

### **Falling Short**

#### **Fatal Error**

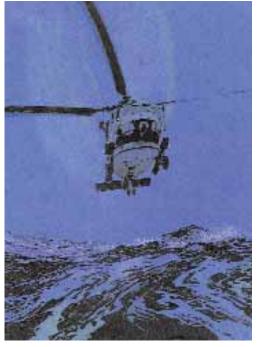
The copilot made altitude calls at 100, 80 and 60 feet followed by three rapid calls for power. Both pilots remember hearing radar altimeter warning system tones at selected altitudes of 100 and 60 feet. The rate of descent continued unabated until just prior to the aircraft's impact with the water. The crew did not see any engine, low rotor, master caution or other warning lights

which would have indicated the pilot attempted to pull more power than the engines were capable of producing. But the pilot did pull sufficient power to decrease the rate of descent just prior to impact. This effort served to avoid injury to the crew but was not enough to avoid crashing .3 miles aft of the ship.

The aircraft immediately rolled right and went inverted. Prior to the SH-60B sinking, the aircrew egressed without significant problems and were rescued by the ship's crew within 22 minutes.

The main problem: crew coordination took a holiday during this night approach.

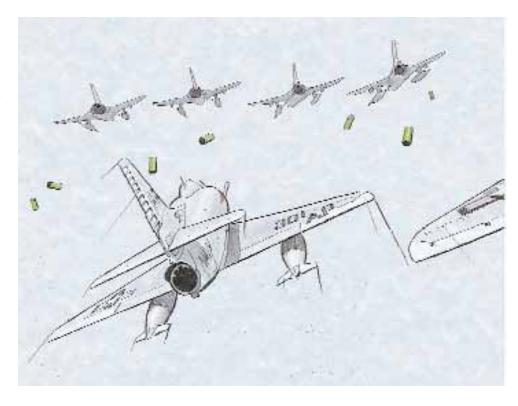
Before a warning could be shouted, the F4Ds dropped their empty rocket pods! The pods came tumbling back through the A4D flight. One struck the A4D division leader's plane squarely on the windshield, shattered the canopy and glanced off the vertical fin. His plane slowly rolled to the right, made two complete rolls, turned inverted and plunged into the ocean. Apparently incapacitated, the pilot did not eject.

With expendable rocket launchers in common usage, it behooves EVERY squadron to take a real close look at their doctrine to make sure this NEVER happens again!
